現場写真集(1)

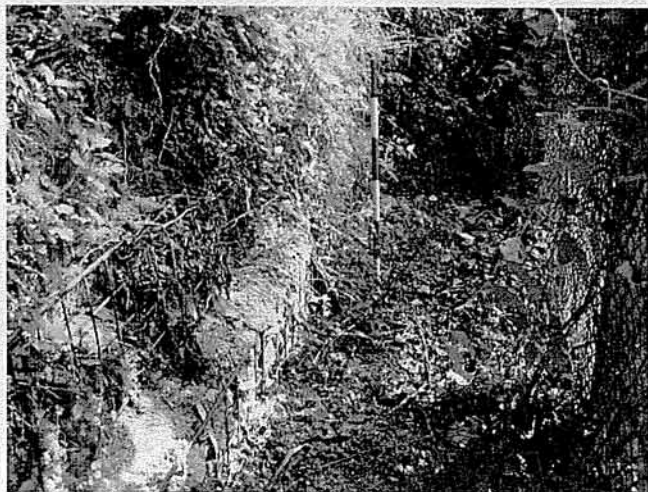
13

φ10~15cmのgr角礫

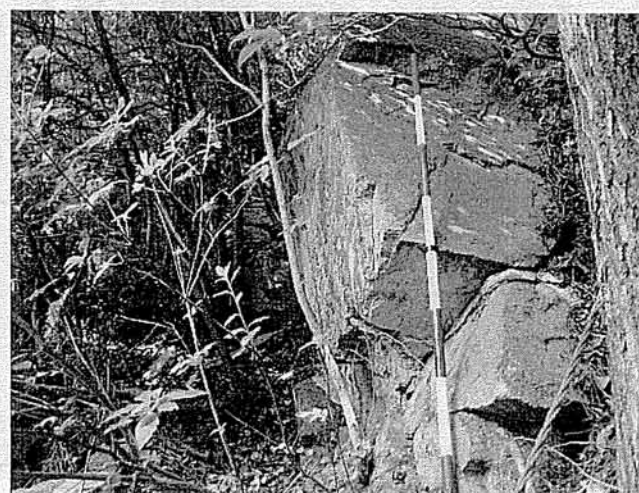
17

転石No.1-5(1.0×0.6×0.5m)

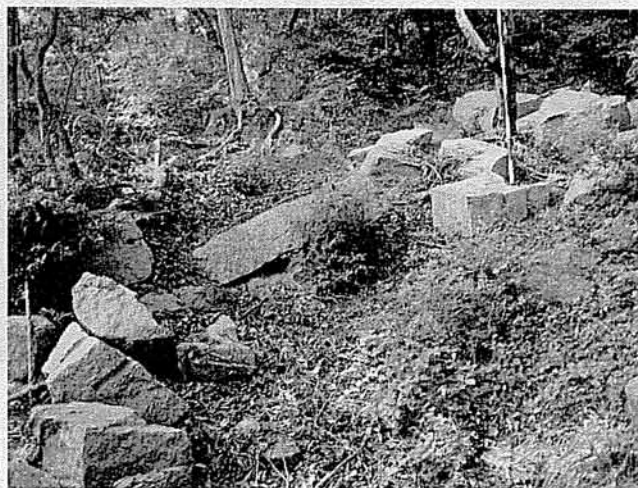
20

φ0.4~0.8mのgr転石(人工)

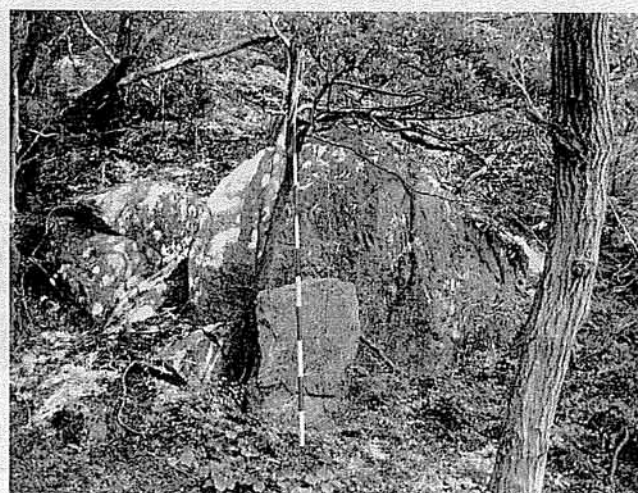
23

0.6×0.5×0.3m

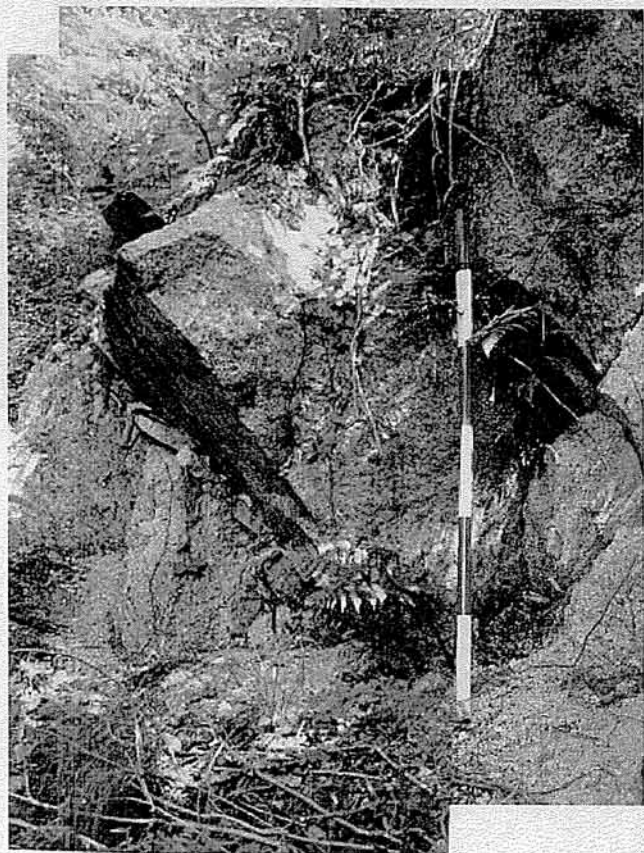
24

やや風化を受けた岩盤 亀裂開口 5~15cm
亀裂沿いに縊み見られる
転石No.2-4(0.7×1.0×1.2m)

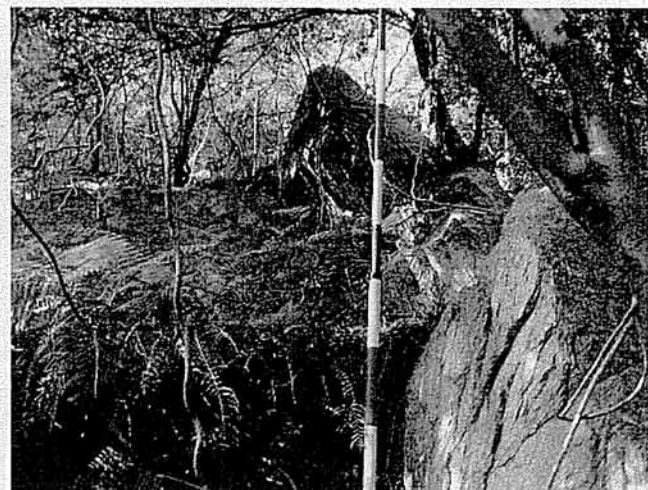
26

転石No.2-1(φ1.5m)

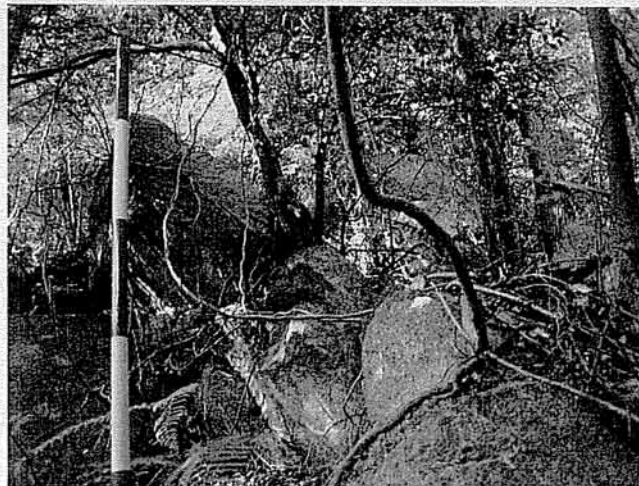
27

転石No.2-1(φ1.5m)

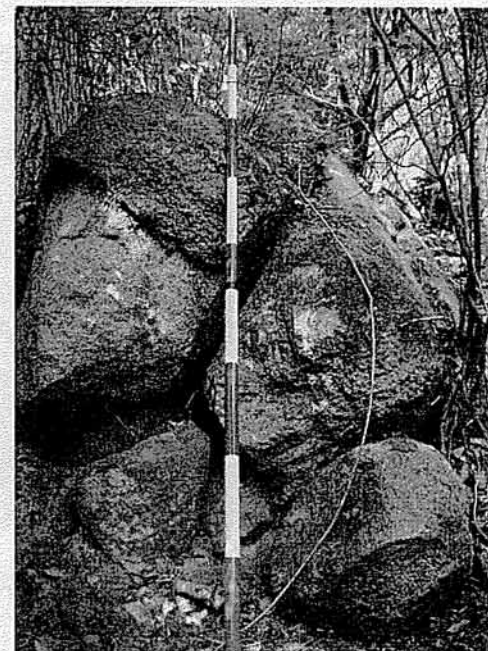
28

転石No.2-3(0.9×0.5×0.5m)

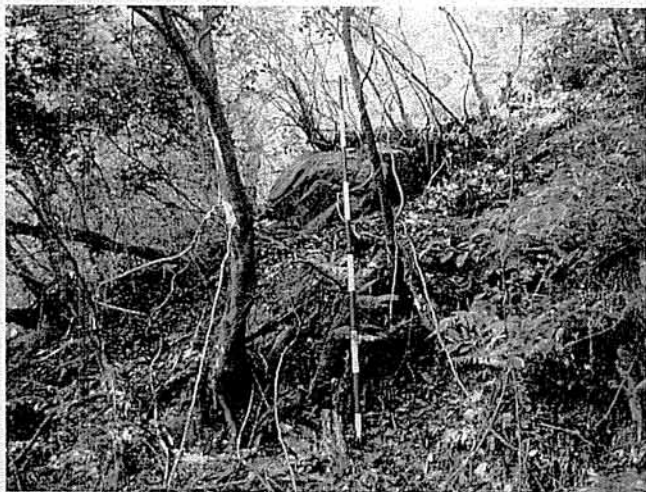
29
転石No.2-2(0.8×1.4×1.0m)

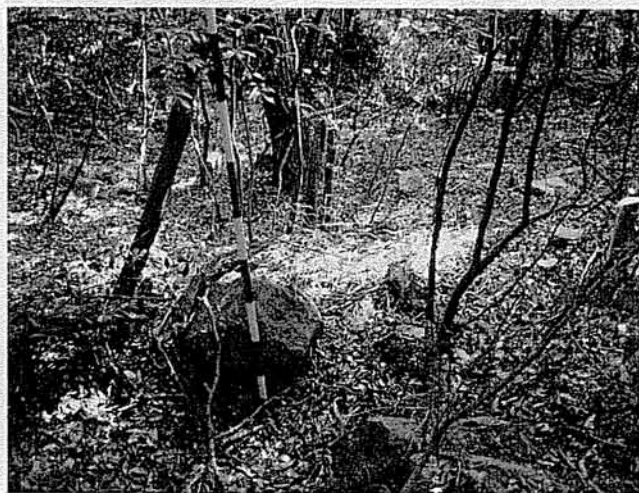
30
φ0.5×0.6×0.7m

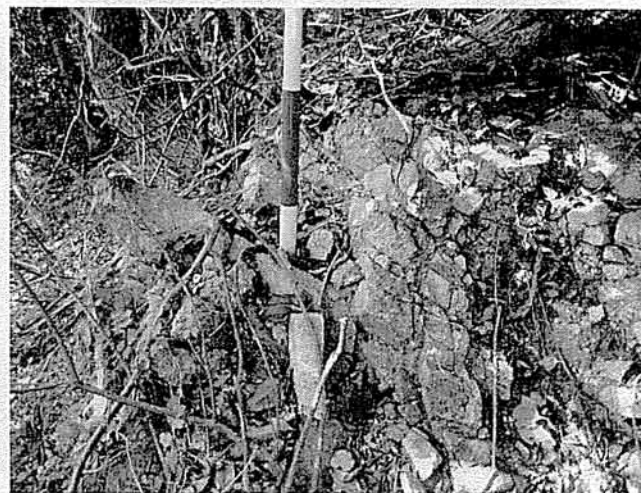
31
CL級gr 2~5cm開口亀裂 下方マサ化
開口亀裂1~2cm 緩み見られる

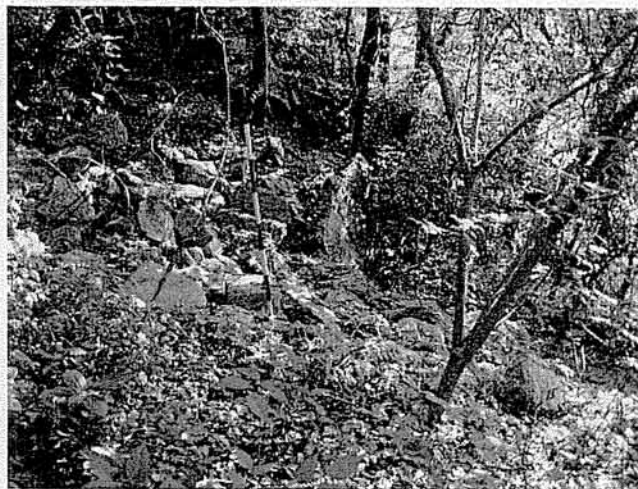
35

φ50~100cmの(人工)転石
転石No.2-5(φ0.5~1.0m散在)

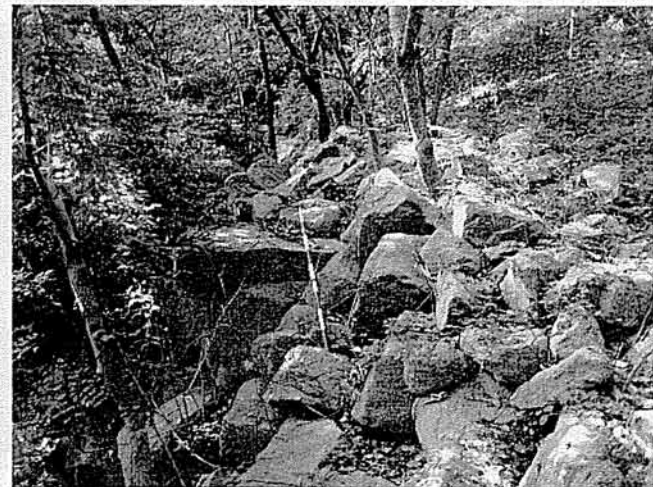
36

φ50~100cmの(人工)転石
転石No.2-6(1.2×0.7×0.6m)

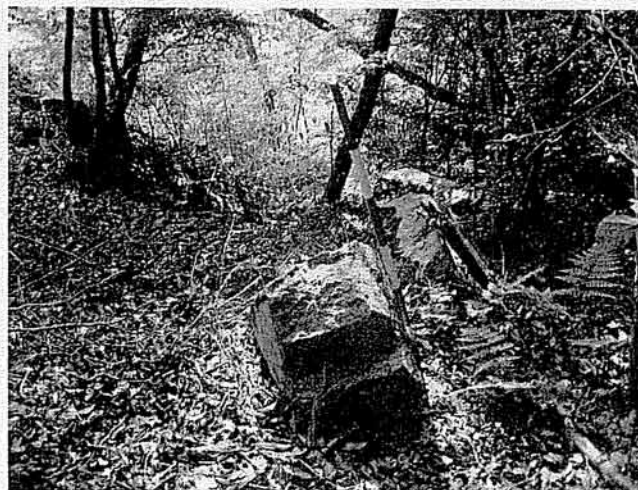
37

転石No.2-8(0.8×0.5×0.4m)
